How to...

...REPAIR A HARTALIGHT FLYSCREEN DOOR

On a recent trip in our 2013 Bailey Approach 760 (based on a Peugeot Boxer 2.2HDI) through France to Spain, we used the flyscreen door on the inside of our habitation door.

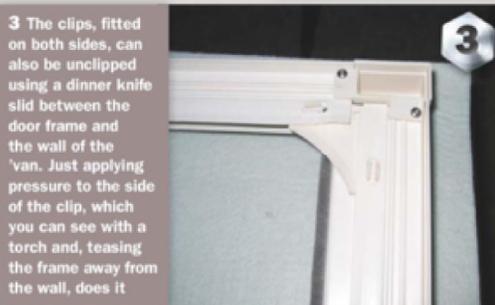
2 Removing the door from the 'van is fairly straightforward. After removing the plastic bungs with a knife, unscrew the two self-tappers at the top corners and two self-tappers through the aluminium frame at the bottom
